Manhole Inspection Summary

Manhole # S25AA1017MH

Insp Date: **1/29/07 10:49 AM**

Location Address: **1201 36TH ST**

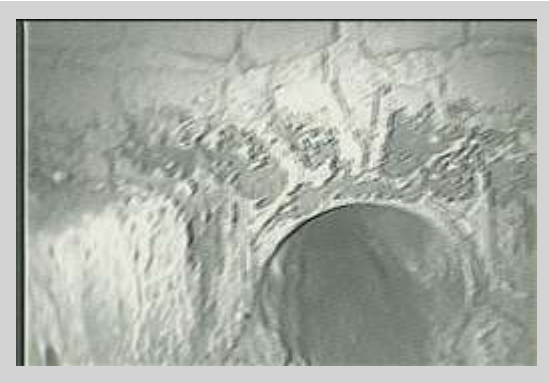
8 in. Circular Gravity Sewer Pipe Out @ 12 O'Clock

Deposits: ☒ None ☐ Mud ☐ Sludge ☐ Debris ☐ Grease

Infiltration: **None** Pipe Seal Cond: **Unknown**

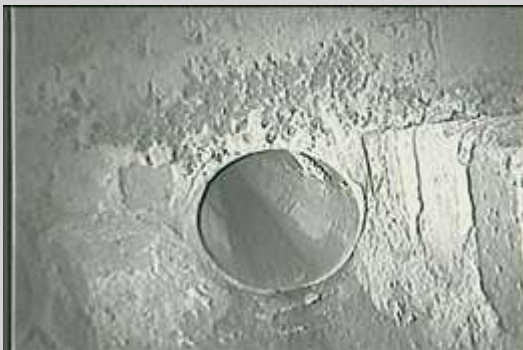
6 in. Circular Gravity Sewer

Infiltration: **None**
